DEPARTMENT OF THE ARMY
HEADQUARTERS III CORPS AND FORT HOOD
FORT HOOD, TEXAS 76544-50

Acid Disposal Site Study
Training Area 65

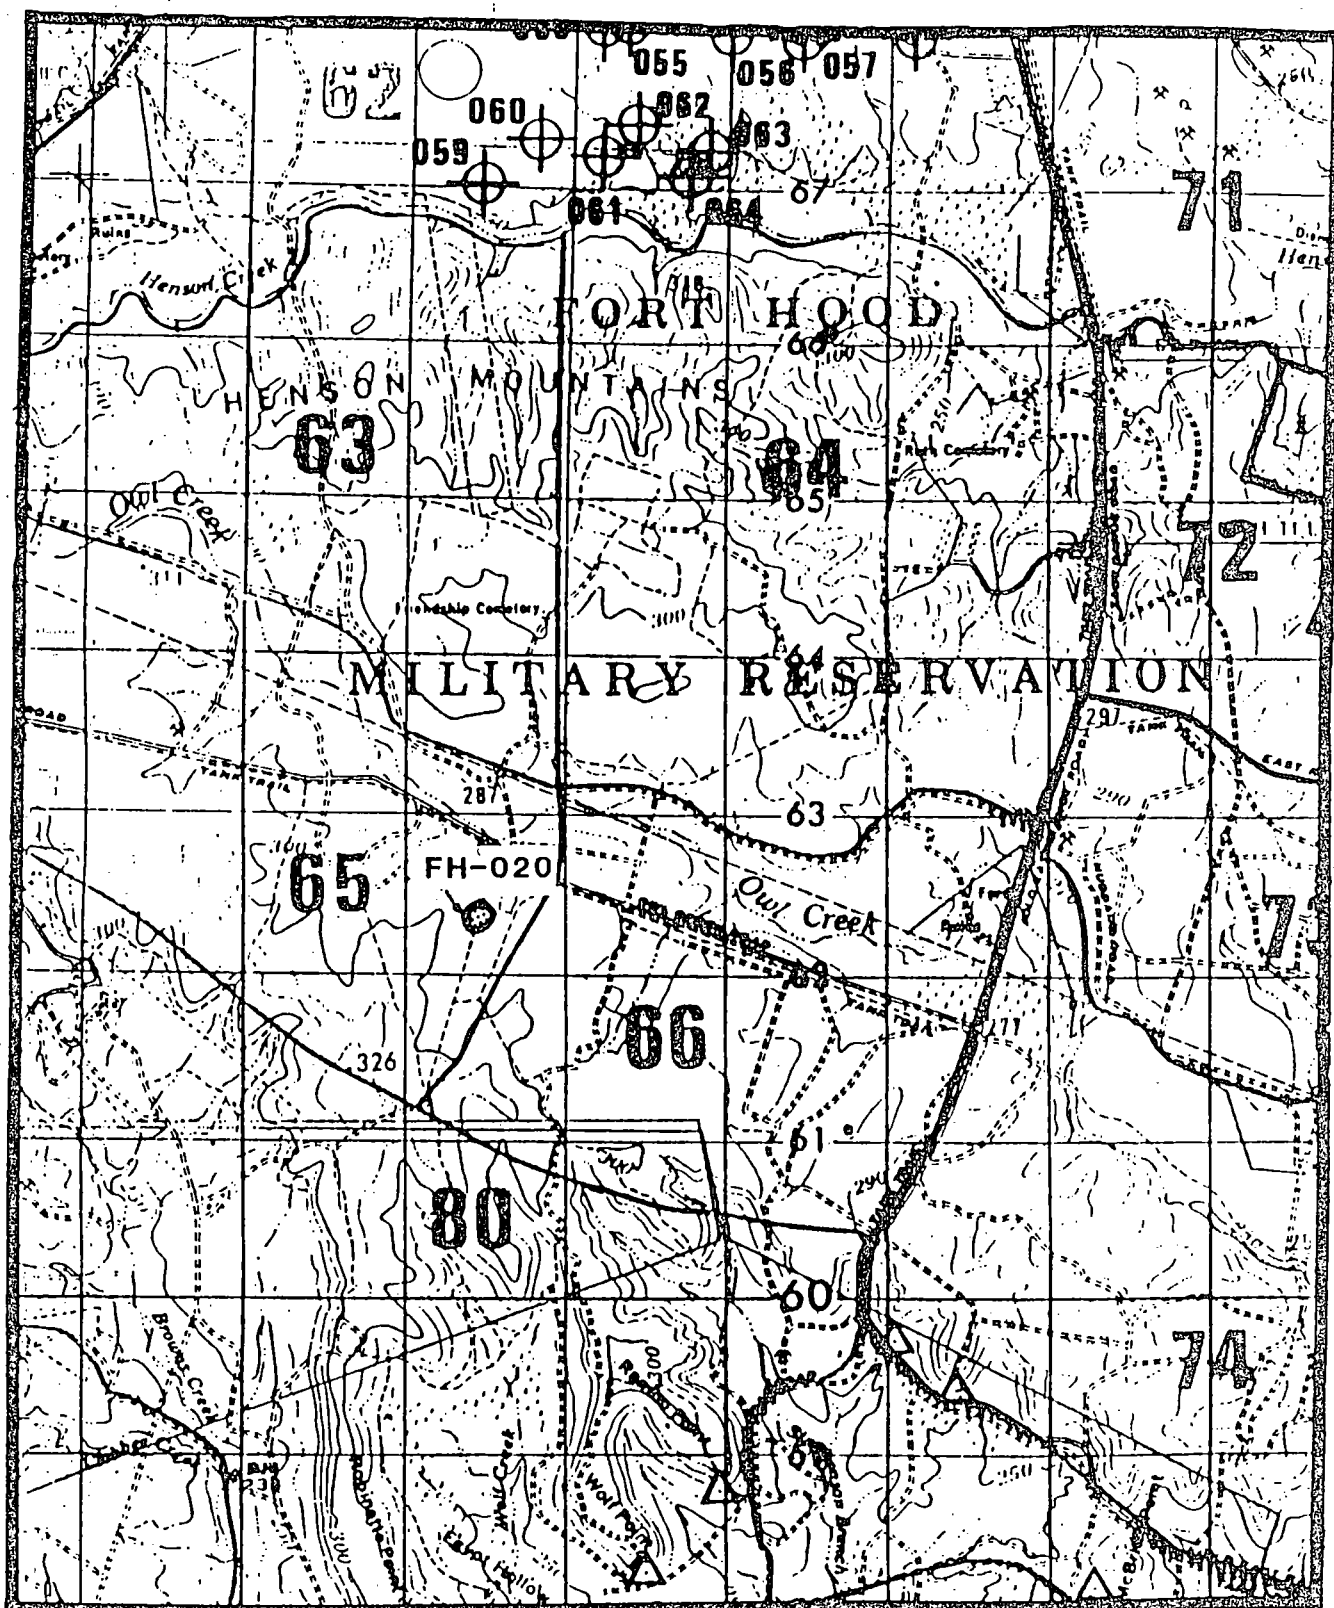
FIGURE I BATTERY ACID PITS

fenced (four or five strand barbed wire) at one time with two gates and signs posted on at least two sides of the fence. See Figure 1. Figure 2 is a drawing of the site and Figure 3 shows the sample locations.

ACID DISPOSAL SITE
TRAINING AREA 65

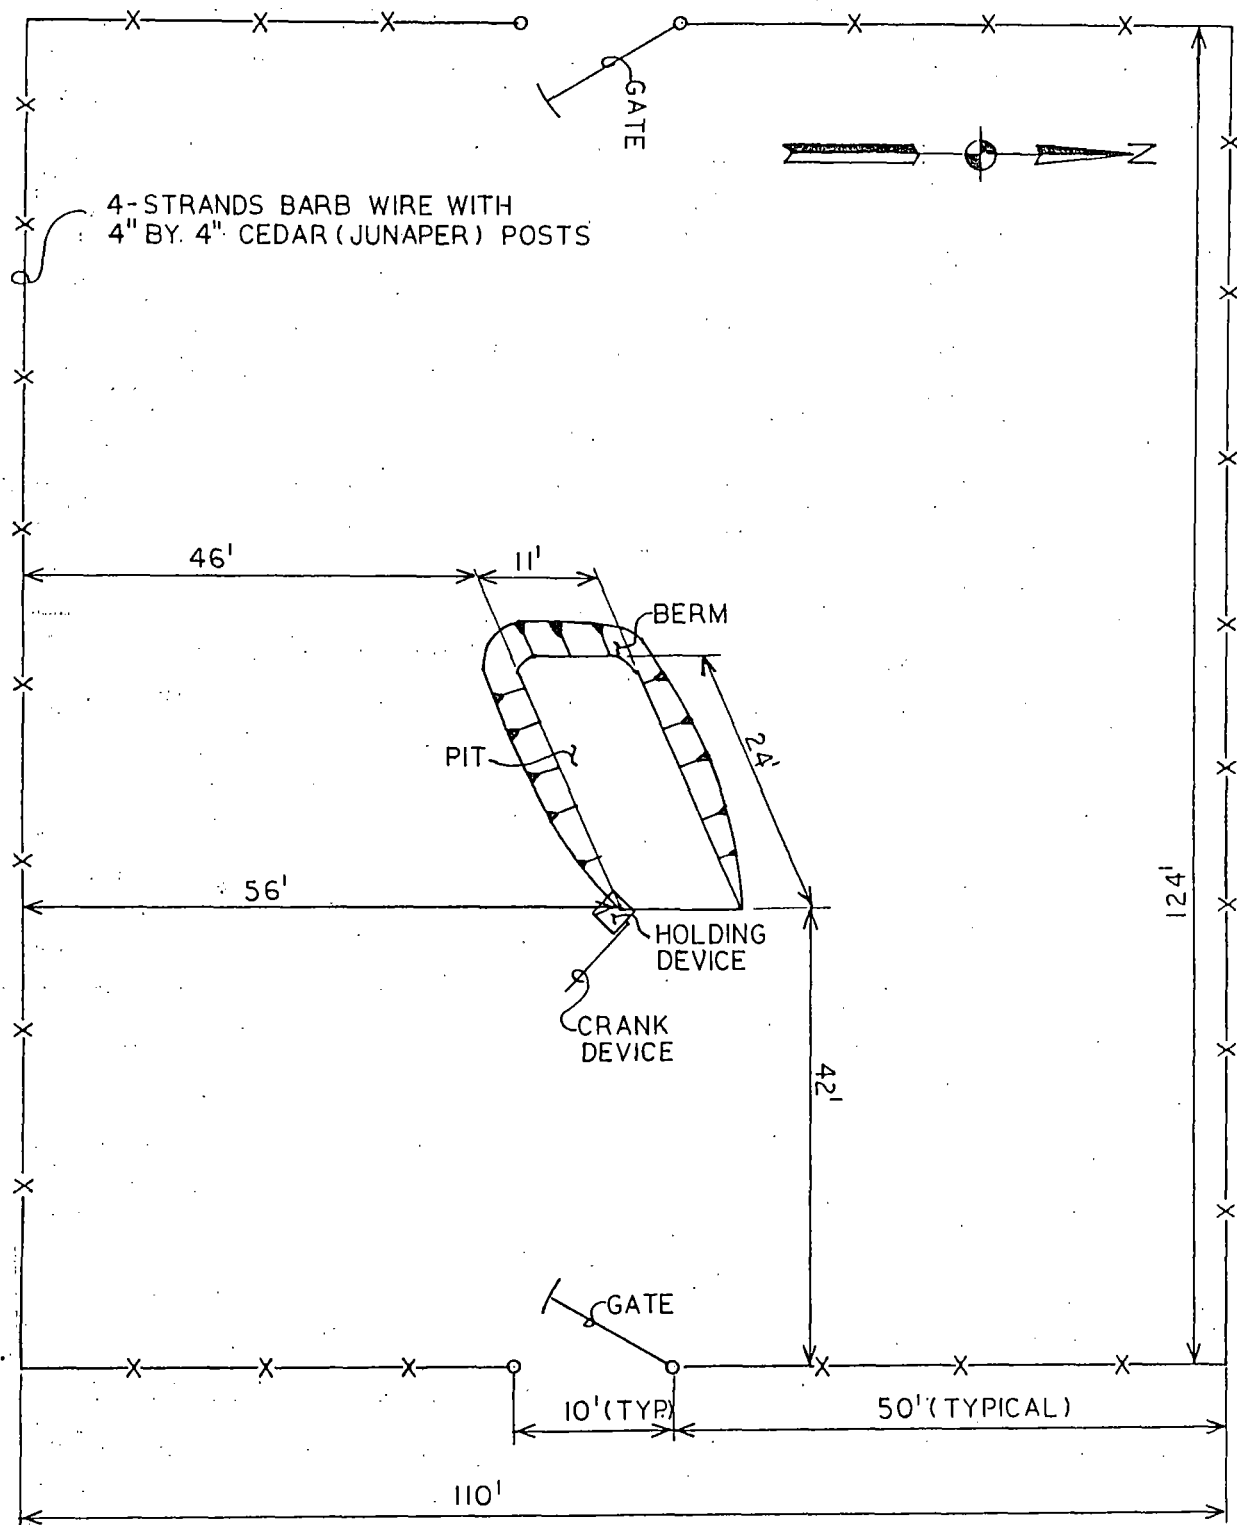
FIGURE 2

b. The site is approximately 110 x 124 feet at the fence line. The actual disposal area was approximately 11 x 24 feet and was about six inches deep. The individual who was in charge of this site had taken steps to ensure that personnel were safe when disposing of the acid. There is a holder in which the container of acid was strapped and a crank handle was turned from a distance of approximately twenty feet behind the container so that the container was tipped and the acid allowed to empty onto the ground within the pit. It appears that only one such pit was used but there is sufficient area for others within the fenced area. Figure 4 thru 8 are photos of the area.

ACID DISPOSAL SITE TRAINING AREA 65

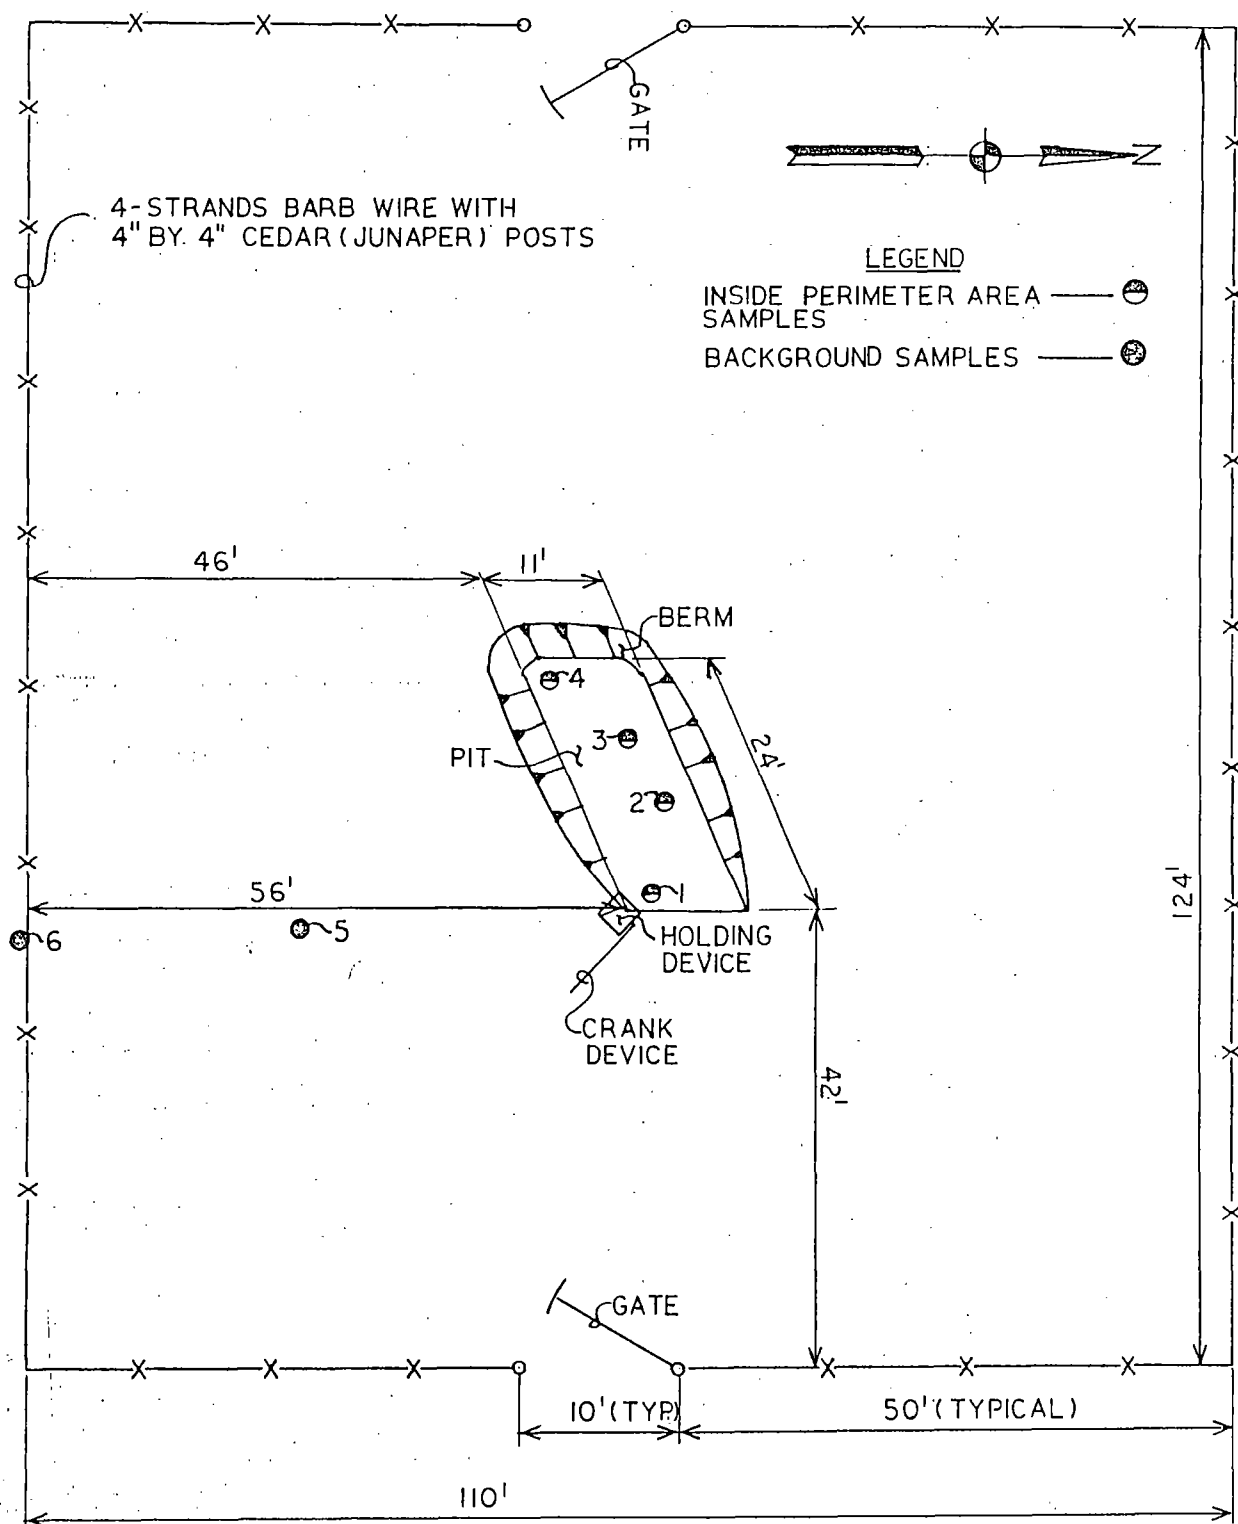
FIGURE 3
SCALE : NOT TO SCALE

c. Six samples were taken on 9215 using a soil sampling tube and washing the tube with hexane and distilled water between samples. Three samples were taken in the pit and were six to eighteen inches deep. One surface sample was taken from in front of the container holder. One surface sample was taken about twenty feet to the south of the pit where the possibility of a second pit could exist. The soil was so hard that only a surface sample was possible. A control sample was taken to the south of the fence line at a distance of approximately 75 feet. Again the soil was hard and rocky and a surface sample was used.

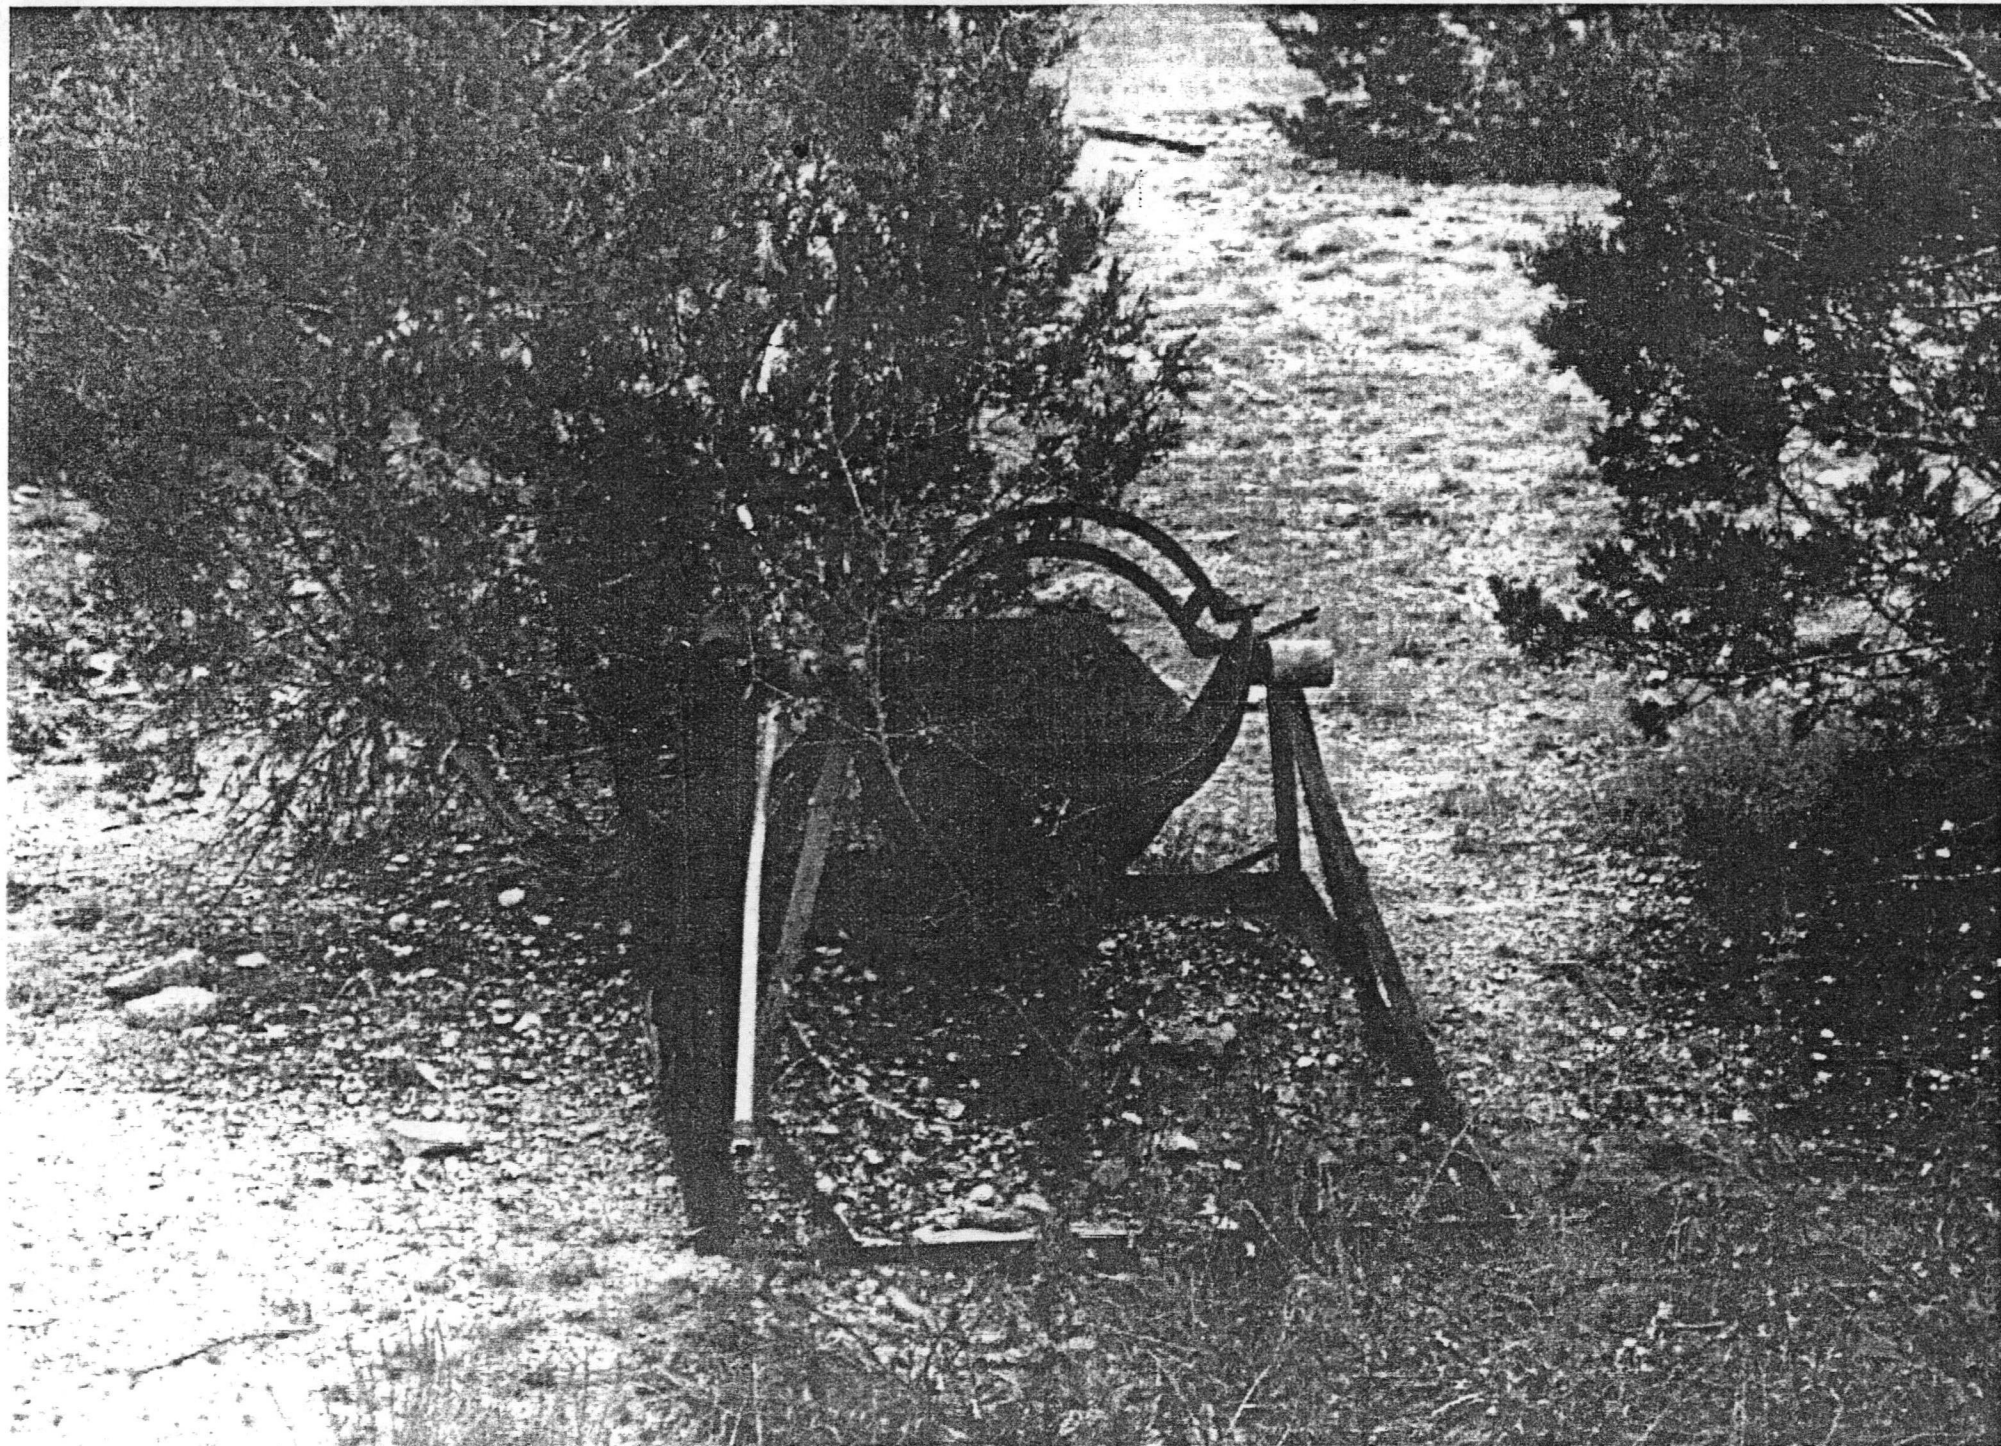
FIGURE 4

CONTAINER HOLDING DEVICE

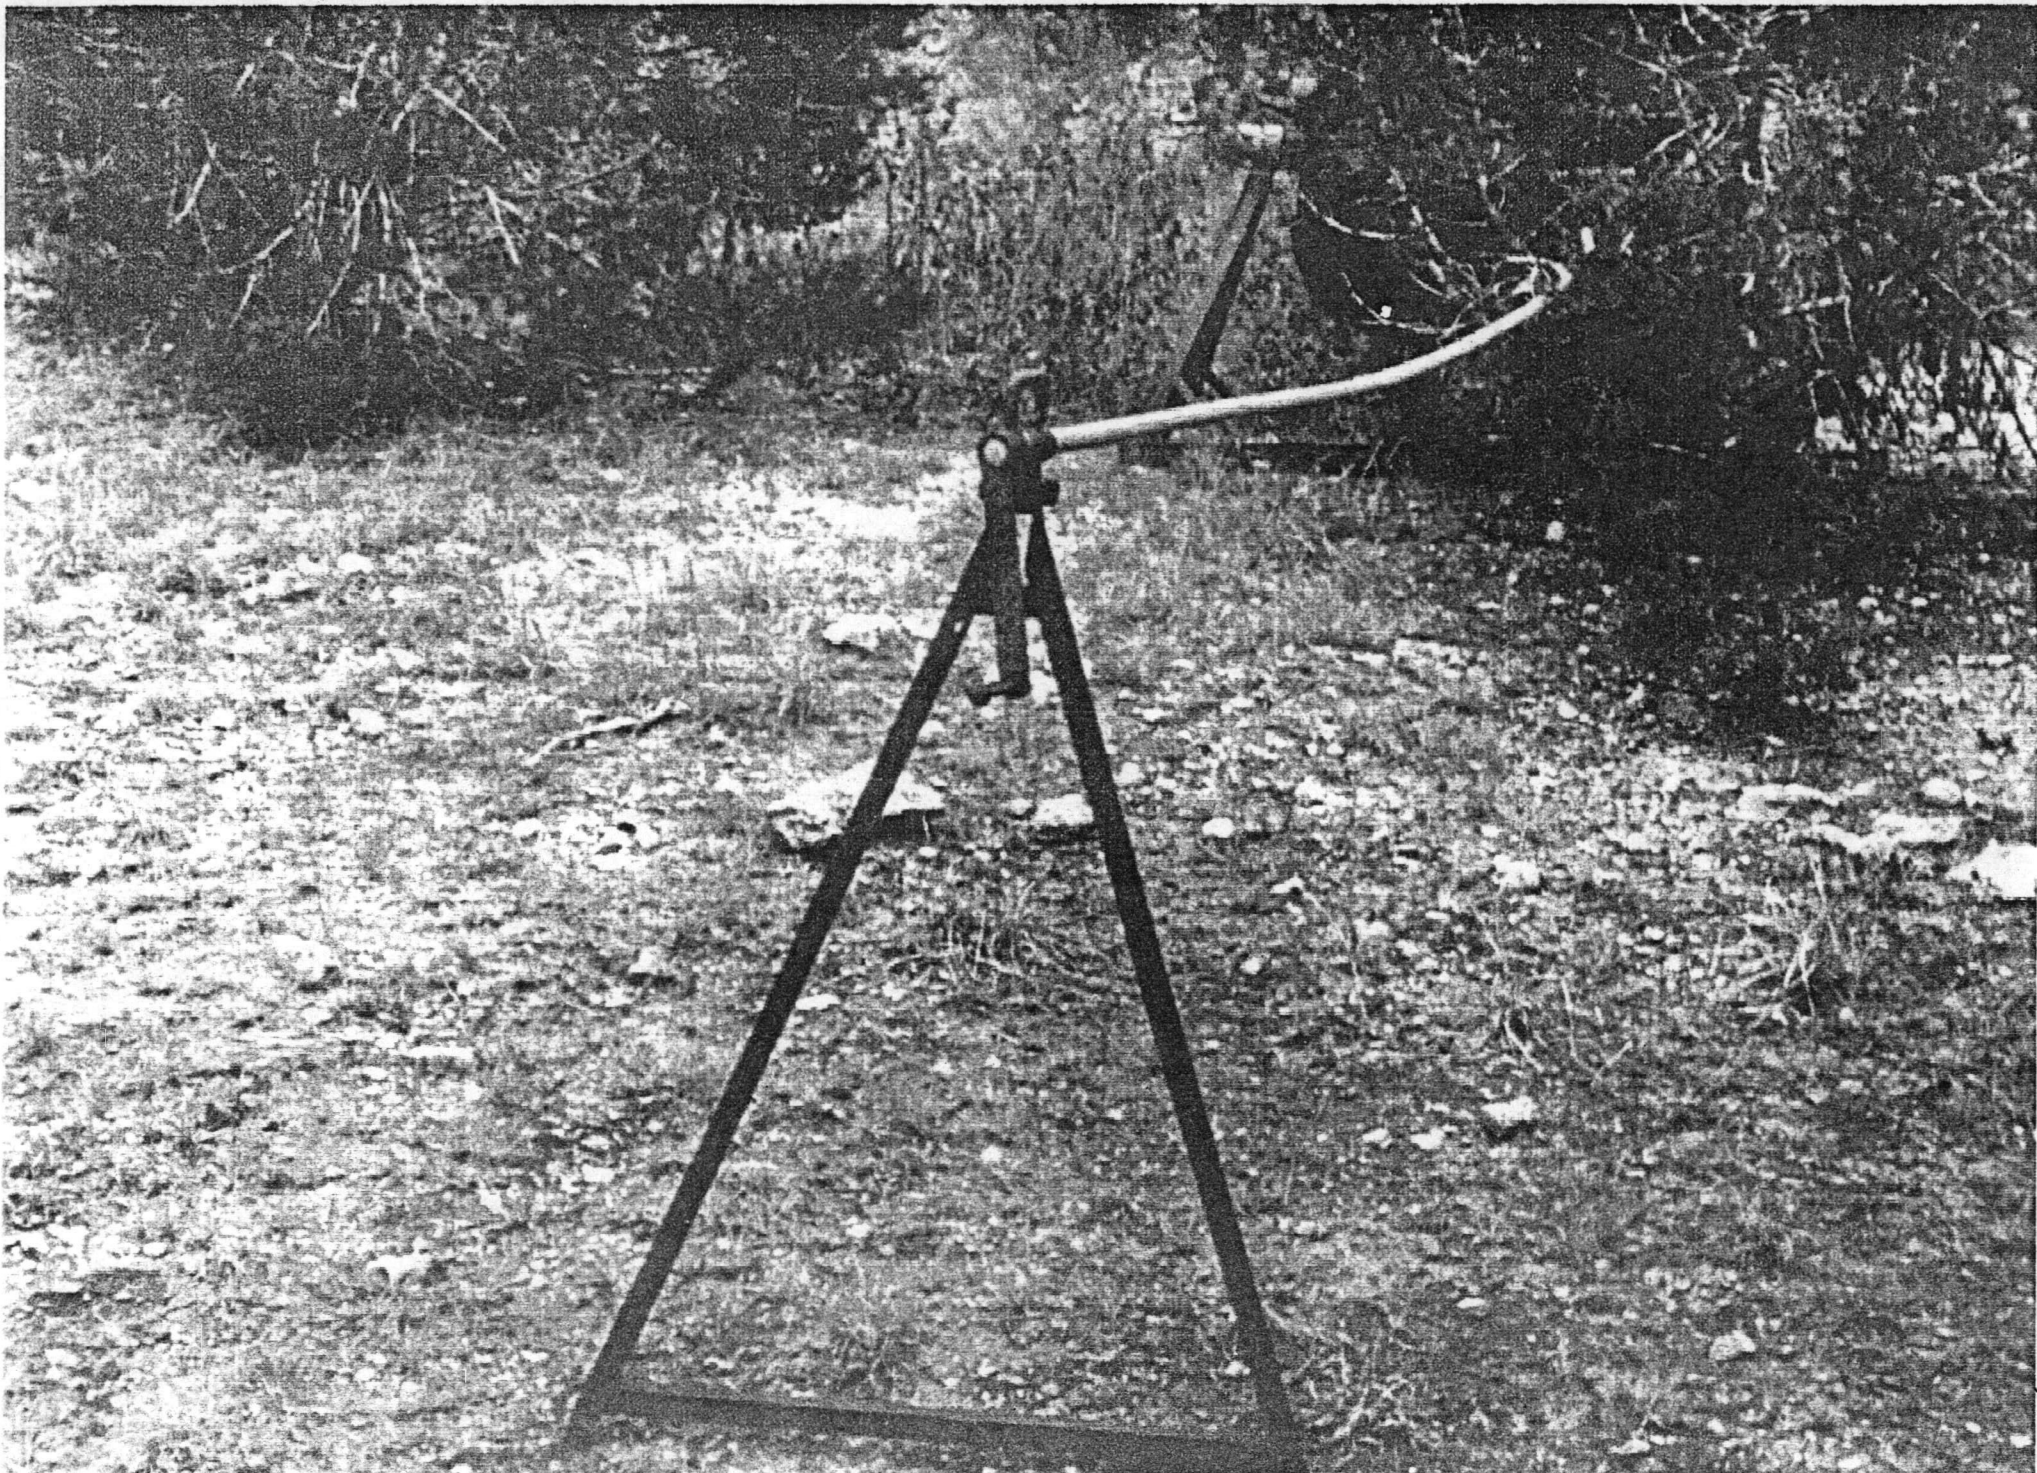
CRANKING DEVICE

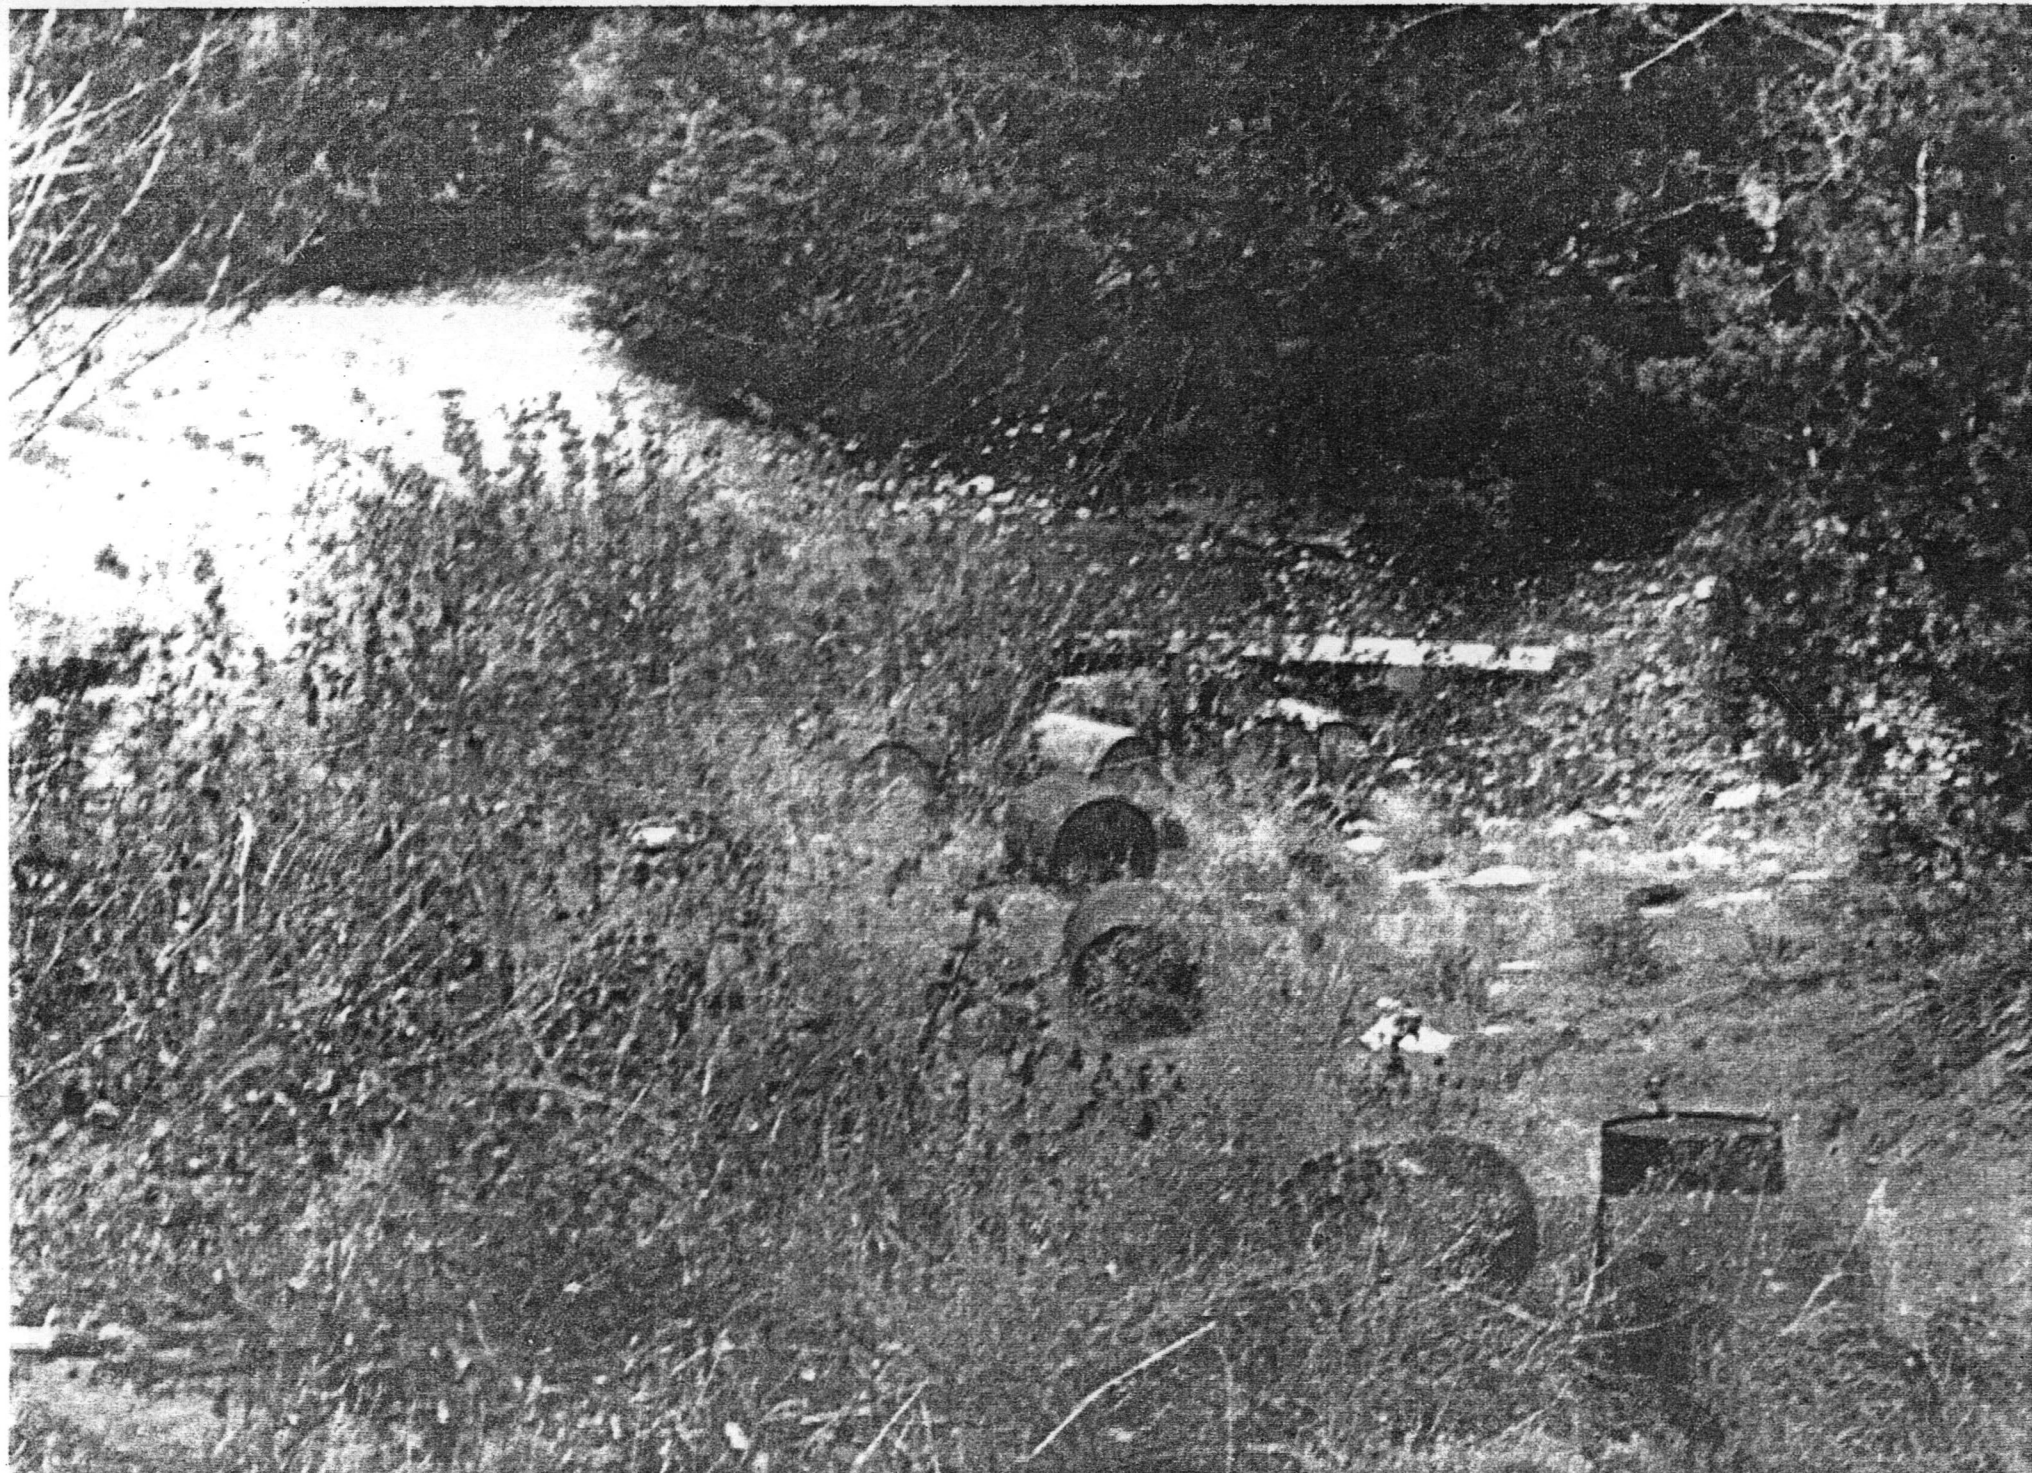
e. It must be noted that since this site was in the impact area the possibility of finding a dud existed. In fact, there is a round that appears to that of an 81mm mortar in the west end of the pit and is a danger to any one who goes into the area.

PIT LOOKIN WEST

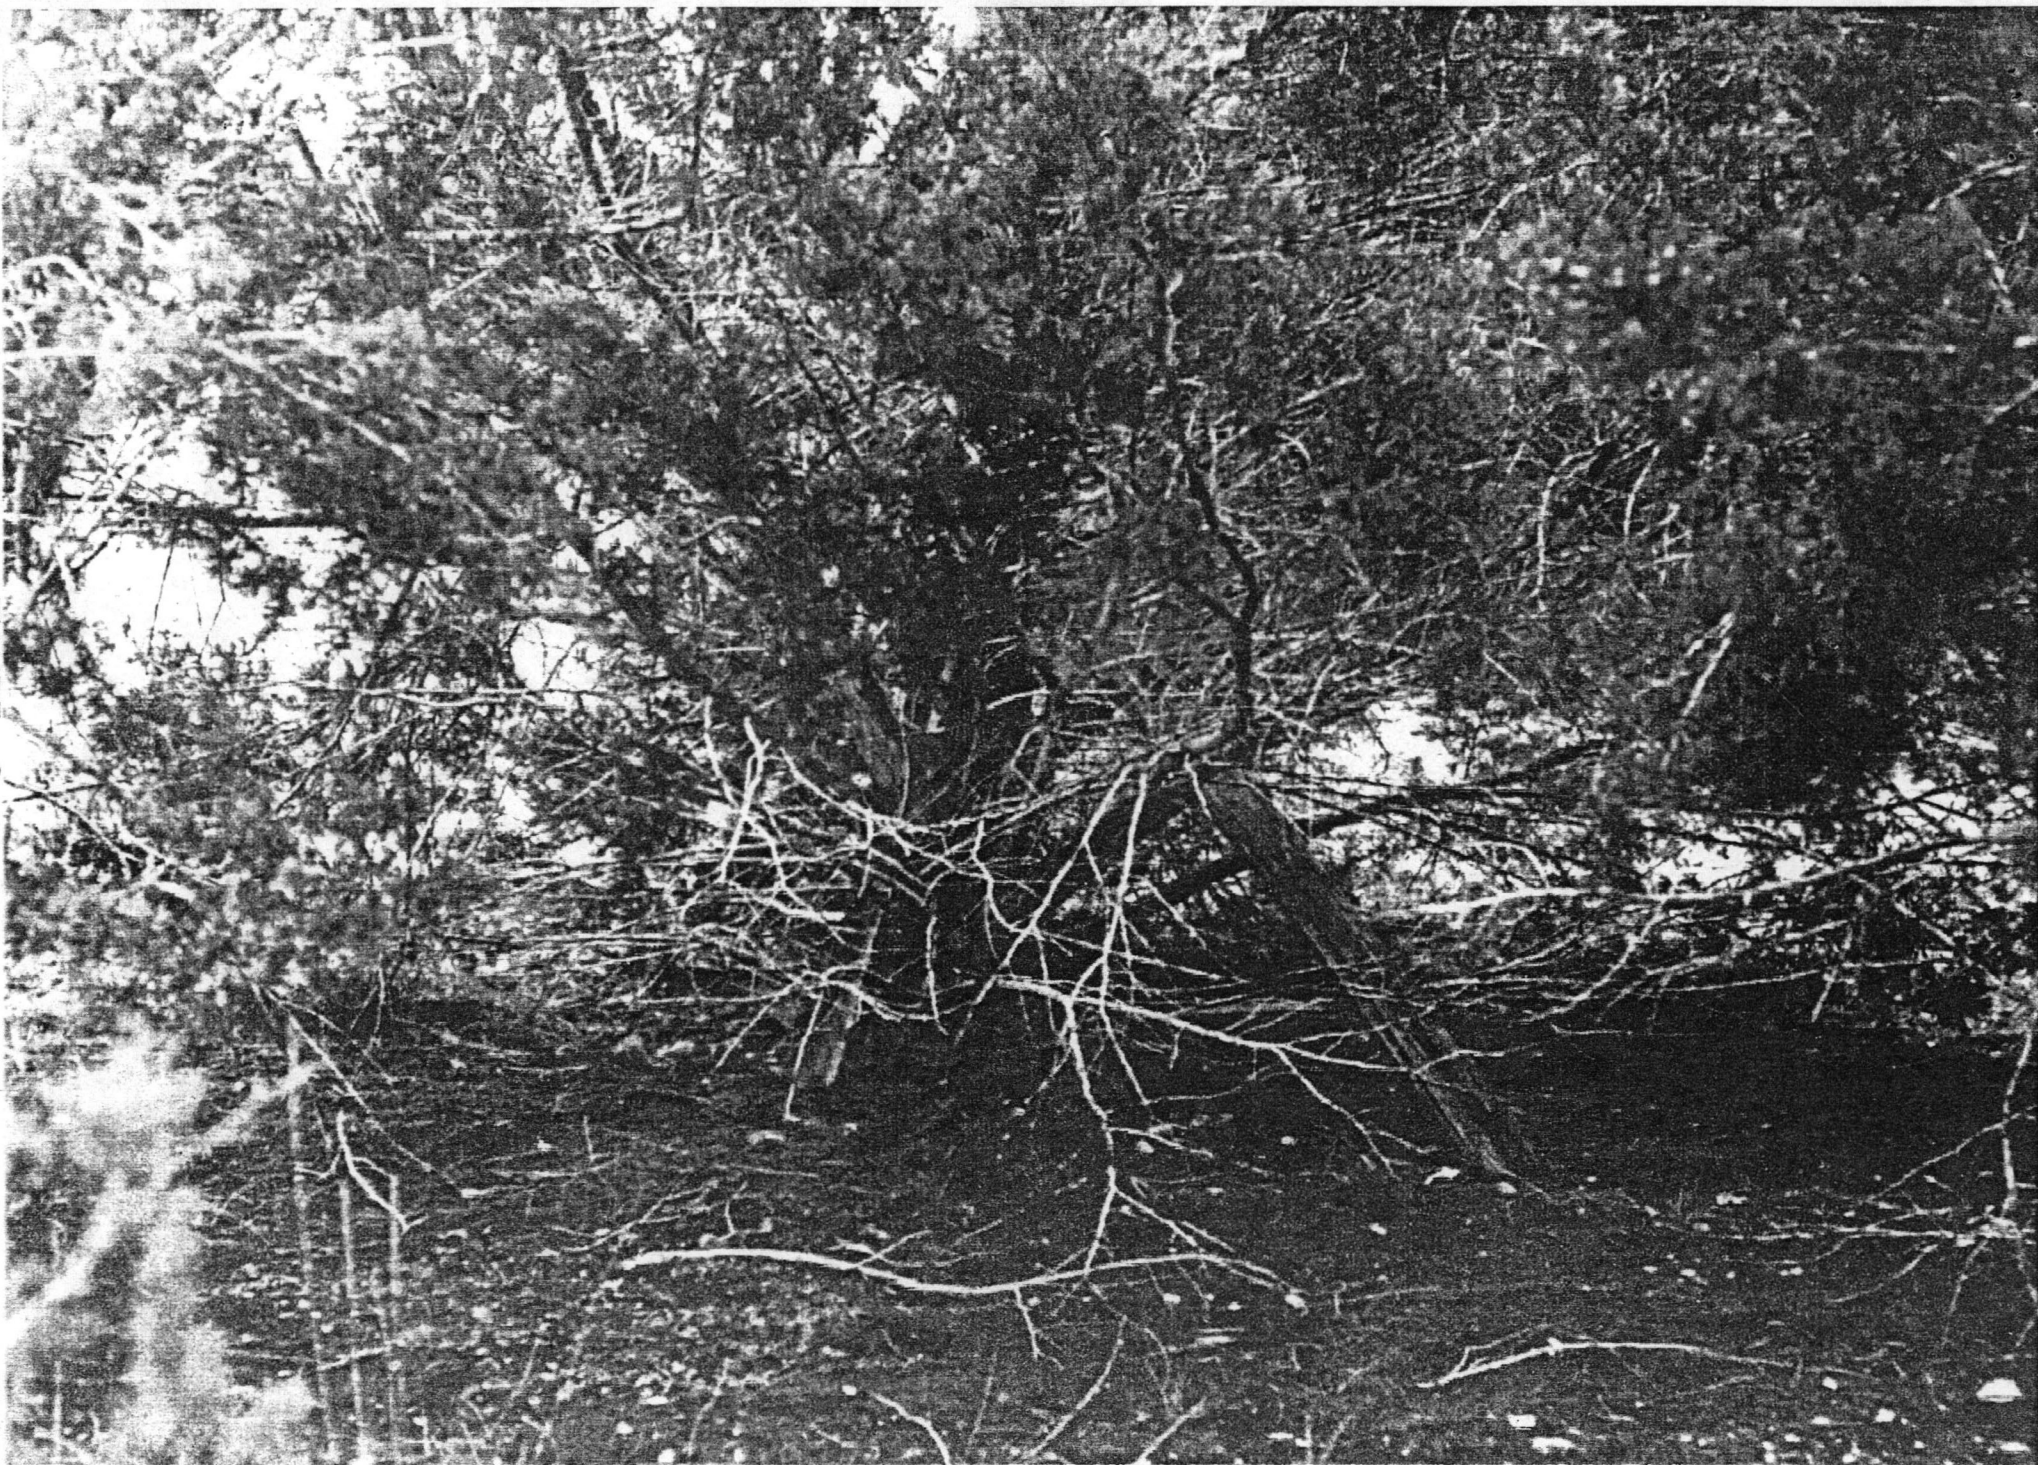
FENCE LINE NORTHEAST CORNER
